ANNUAL REPORT

MAPLETON
WASTEWATER POLLUTION CONTROL PLANT

FOR THE PERIOD:
JANUARY 1, 2021 – DECEMBER 31, 2021

Prepared for the Township of Mapleton
by the Ontario Clean Water Agency

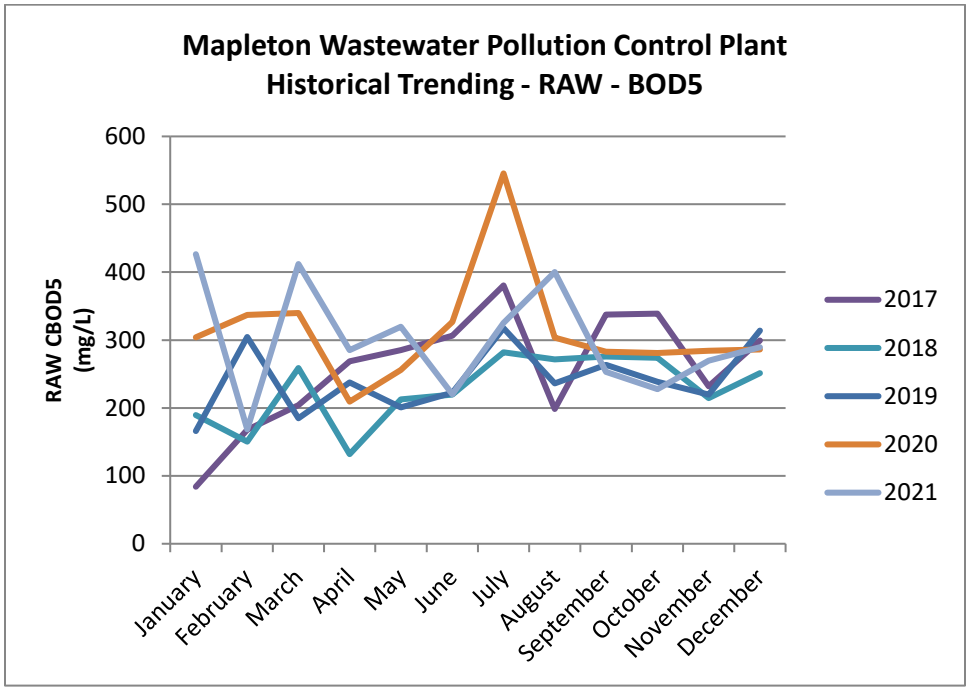
Figure 1.

The below graph shows historical raw Biochemical Oxygen Demand (BOD_5) trending from 2017 to 2021. A review of the trends from the last 5 years for BOD_5 shows that the average BOD_5 concentration in the raw sewage had fluctuated year per year. A continued decrease in BOD_5 loading was observed in 2021 comparatively to previous years.

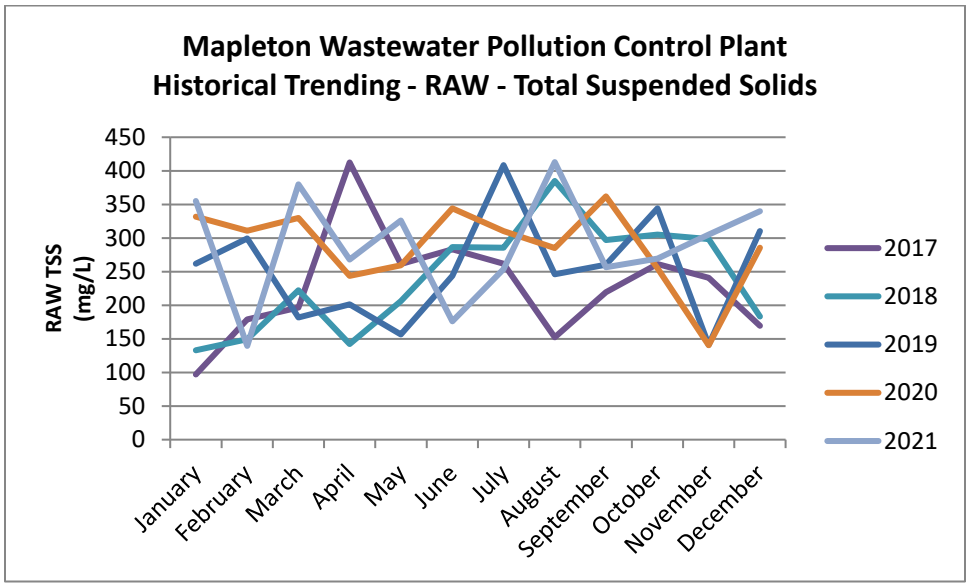
Figure 2.

The below graph shows the historical raw Total Suspended Solids trending from 2017 to 2021. A review of the current 2021 trends versus the last 5 years has shown a slight increase in loadings of Total Suspended Solids for the parts of the year.

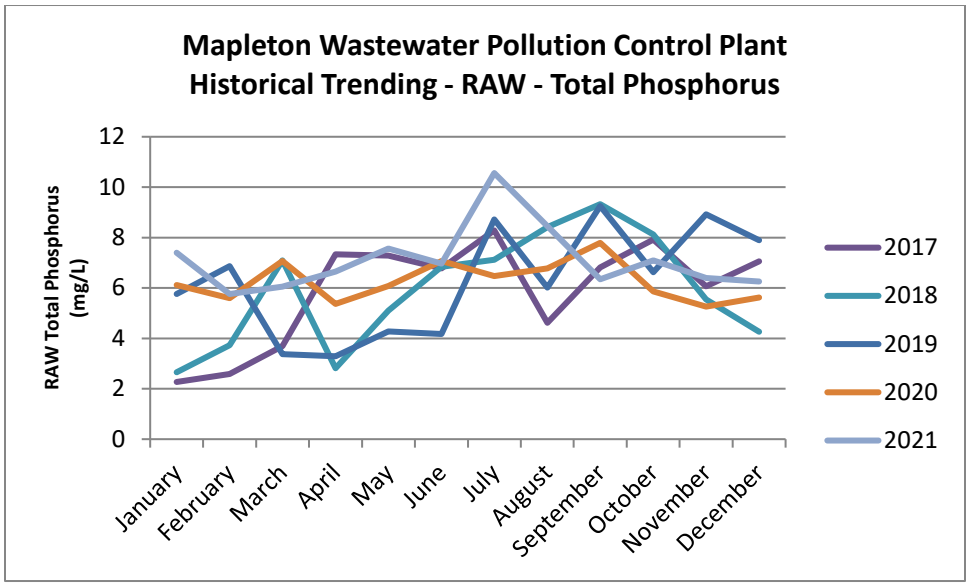
Figure 3.

The below graph shows the historical raw Total Phosphorus trending from 2017 to 2021. A review of the current 2021 trends versus the last 5 years has shown a slight increase in loadings of phosphorus for the parts of the year.

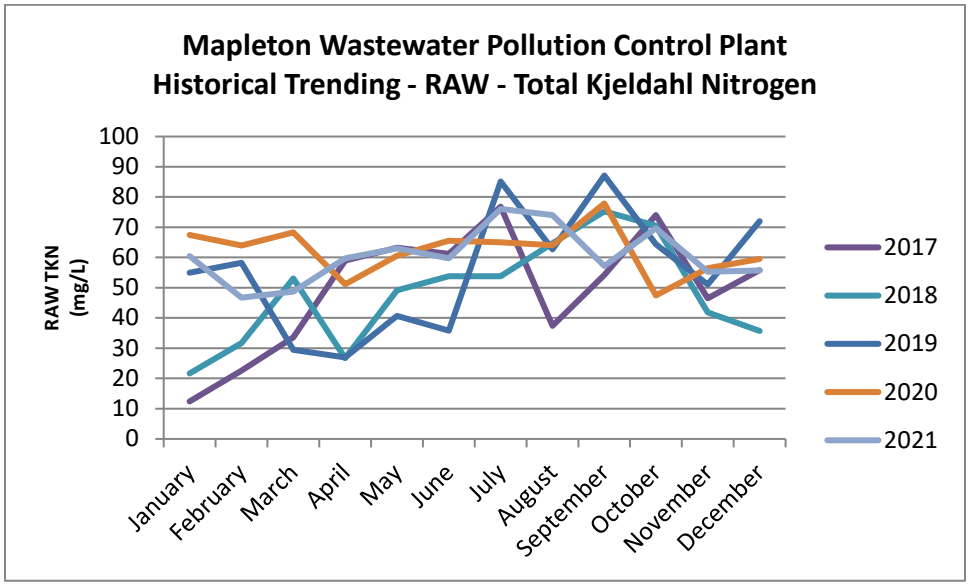
Figure 4.

The below graph shows the historical raw Total Kjeldahl Nitrogen trending from 2017 to 2021. A review of the 2021 trends versus the last 5 years for TKN has shown a slight increase in loadings concentrations to previous years.

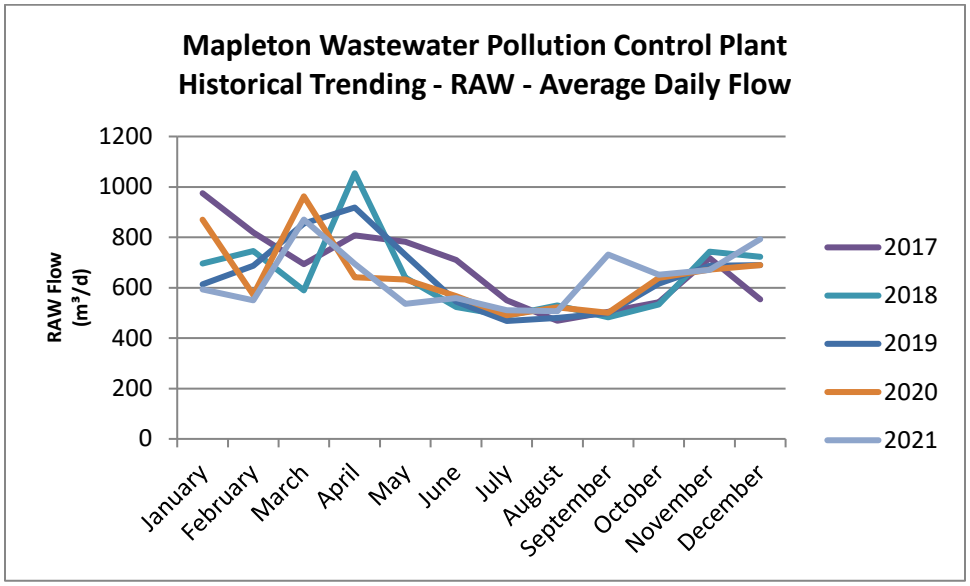
Figure 5.

The below graph shows historical raw flow trending from 2017 to 2021. The graph shows that the average flows have remained fairly consistent. There is a consistent peak in the months of March-April which would represent warmer temperatures resulting in snow melt and seasonal precipitation.

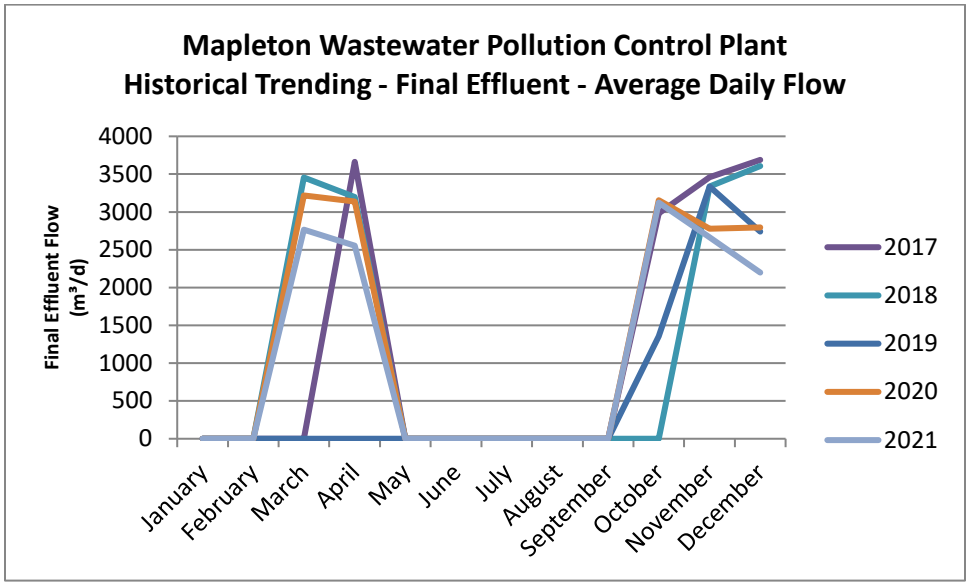
Figure 6.

Effluent Flow: The below graph shows historical final effluent flow trending from 2017 to 2021. The graph shows that during the discharge periods the final effluent average flows have remained fairly consistent between the discharge periods.
